**OPERATION OF A FORCED CIRCULATION,  
CROLOY 9 M, MERCURY LOOP TO STUDY  
CORROSION PRODUCT SEPARATION TECHNIQUES**

*by D. B. Cooper and E. J. Vargo*

Prepared under Contract No. NAS 3-2538 by  
THOMPSON RAMO WOOLDRIDGE, INC.  
Cleveland, Ohio  
*for*

**NATIONAL AERONAUTICS AND SPACE ADMINISTRATION • WASHINGTON, D. C. • APRIL 1965**

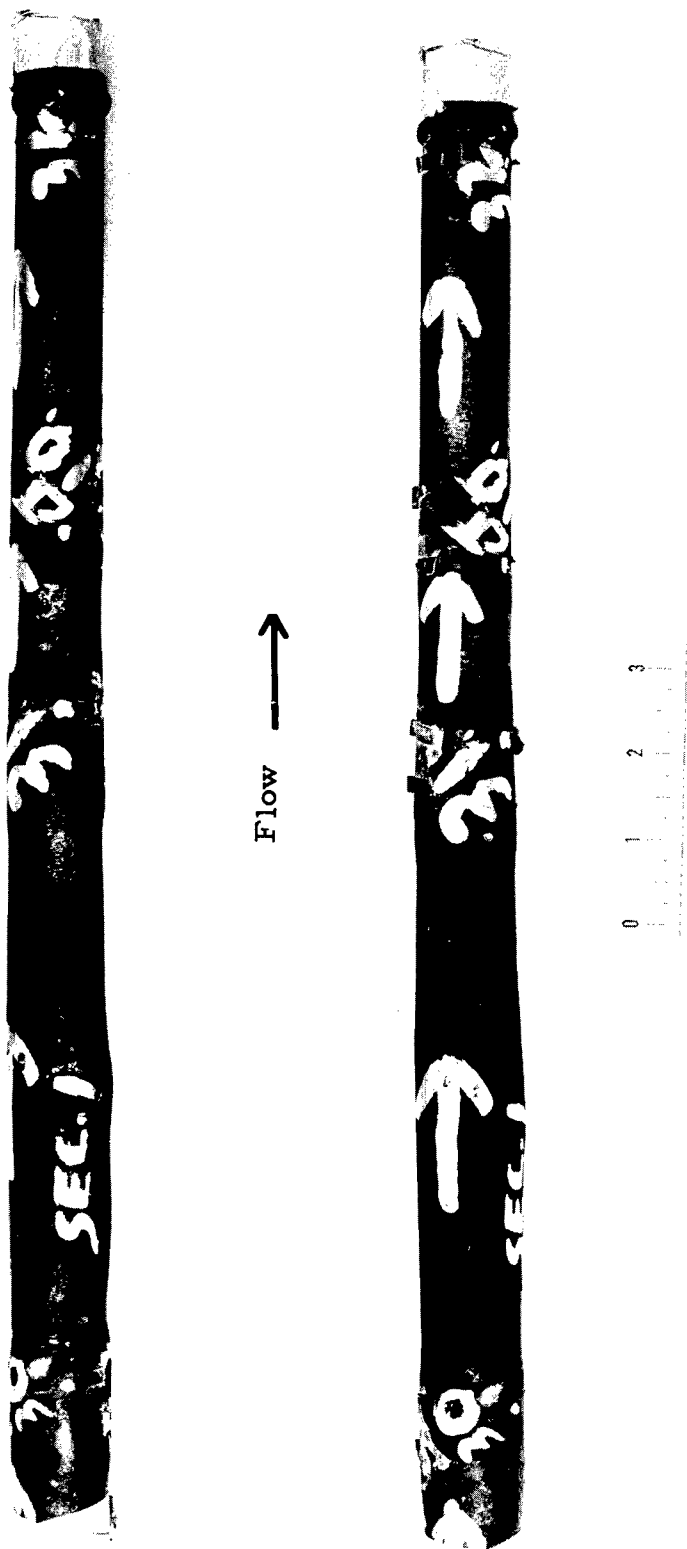
Figure 27 Appearance of the Superheater Outlet Section Showing the Deformation which Occurred.

The wall temperature of this failed portion of the superheater, by excessive creep, was  $1405 \pm 10^{\circ}\text{F}$  as indicated and recorded by several thermocouples. At this elevated temperature, the creep strength of Croloy 9M is practically nil; stress to cause 0.001% per hour creep is less than 1500 psi. Since the available strength of the Croloy 9M was thus practically zero, the hoop stress for the superheater outlet section was calculated based only on the Type 316 SS clad portion of the tube and mercury vapor pressure of 269 psia. A value of 1965 psi hoop stress was obtained which is substantially lower than the reported 0.0001% per hour creep strength of 4000-5000 psi.<sup>(6, 7)</sup> Since the hoop stress was not excessive for this austenitic steel, the reported temperatures were reviewed for possible error. Since three thermocouples reported  $1405 \pm 10^{\circ}\text{F}$  and since the Type 316 SS did not have oxide scale, there was no reason to doubt the reported temperature. However, the observed metallurgical changes in the Type 316 SS mentioned above may be the cause of the accelerated creep and thus could be the primary cause of failure of the tubing. Obviously, the cause of the creep failure of the duplex tubing in the superheater outlet section cannot be determined without further mechanical testing.

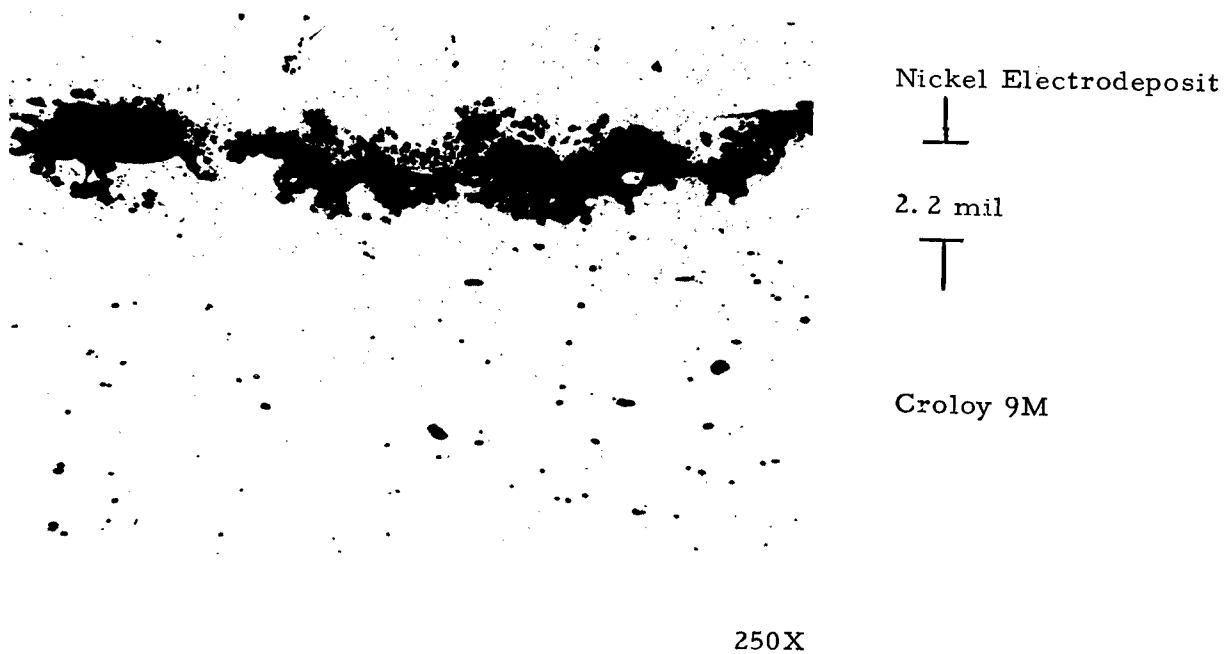
Figure 31. Intergranular Corrosion of Boiler Midsection.  
Unetched

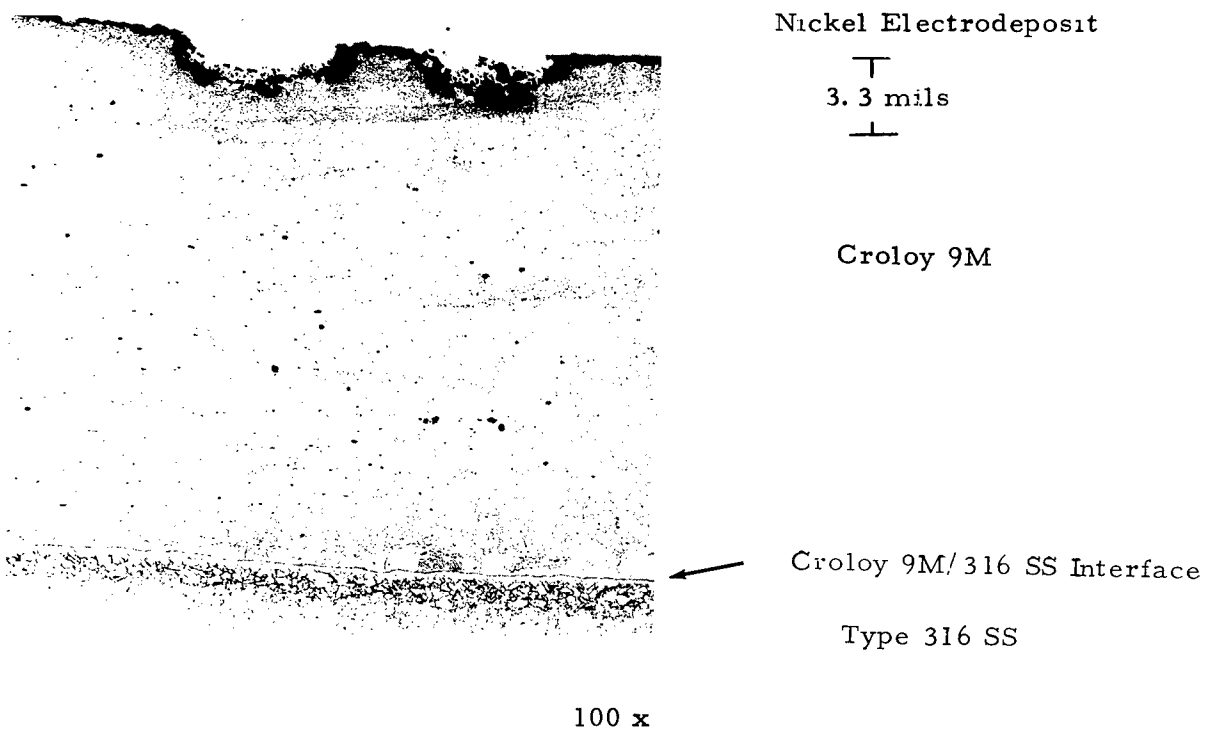
Figure 32. Intergranular Corrosion of Boiler Midsection.

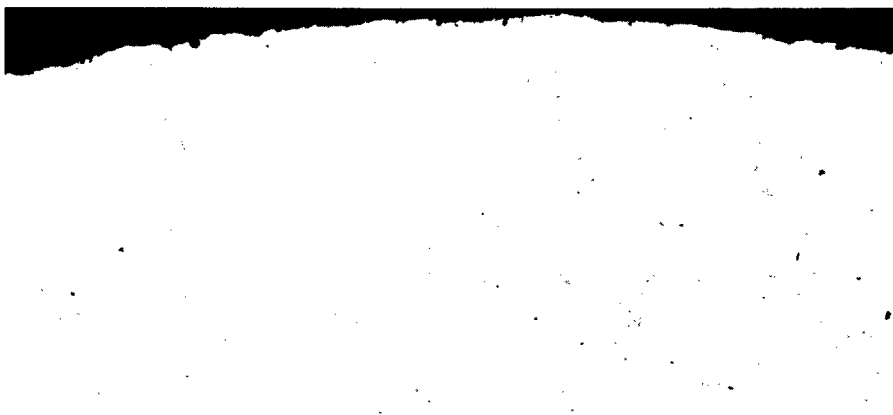
a) Intergranular Corrosion of Swirl Wire at Boiler Inlet

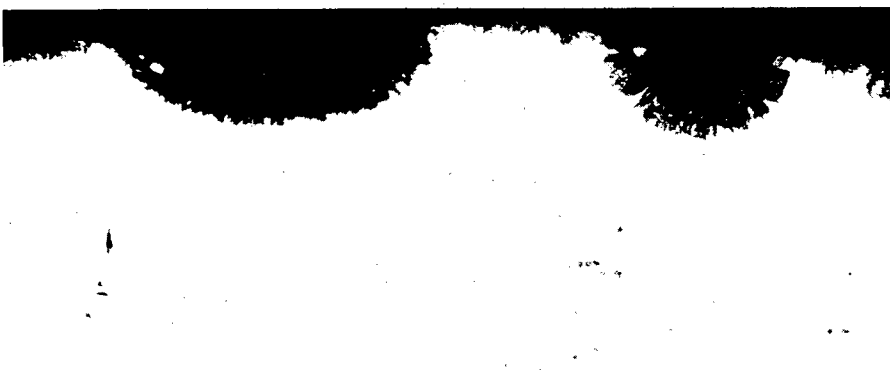
b) Intergranular Corrosion of Swirl Wire at Boiler Mid-Section

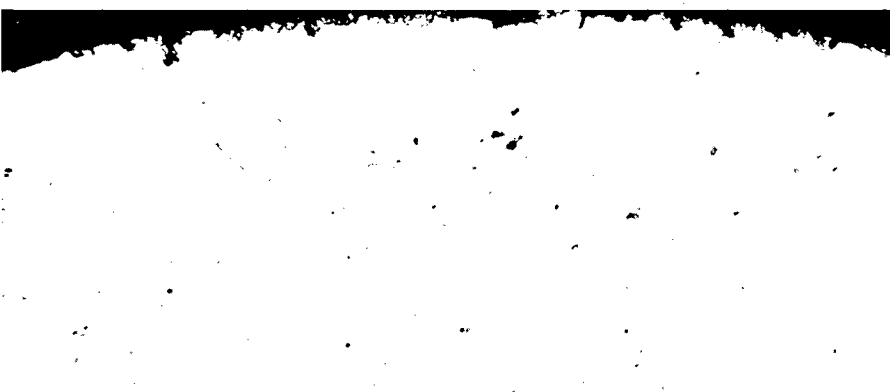
c) Intergranular Corrosion of Swirl Wire at Boiler Liquid/Vapor Interface

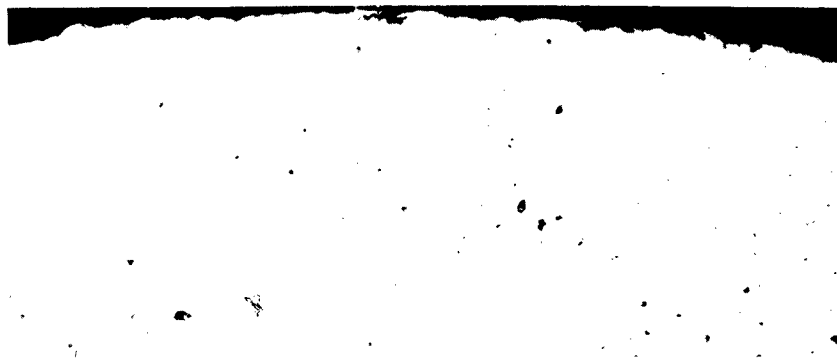
f) Crevice Corrosion of Swirl Wire at Superheater Outlet

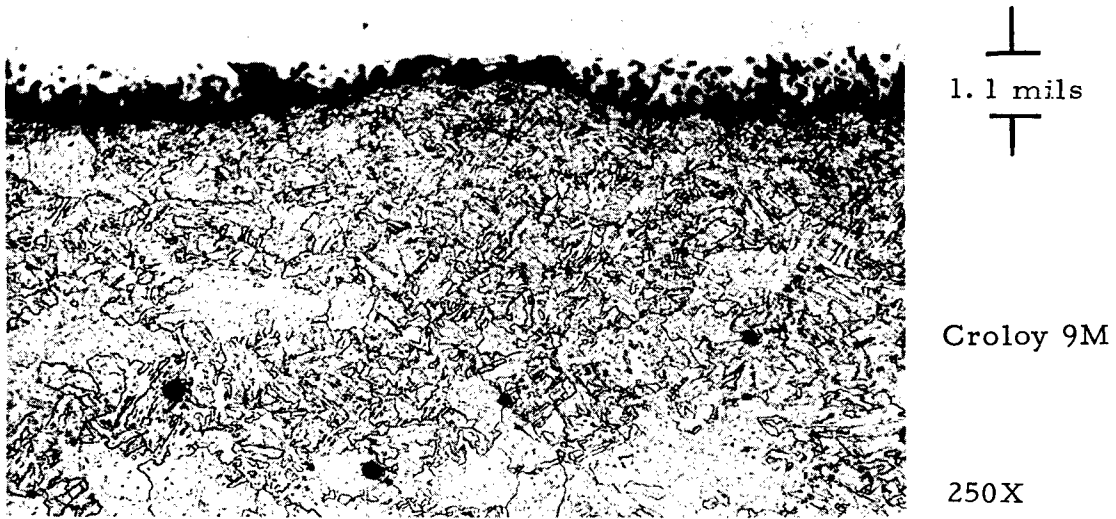
Figure 34. Intergranular Corrosive Attack of Boiler Wall Near Outlet.

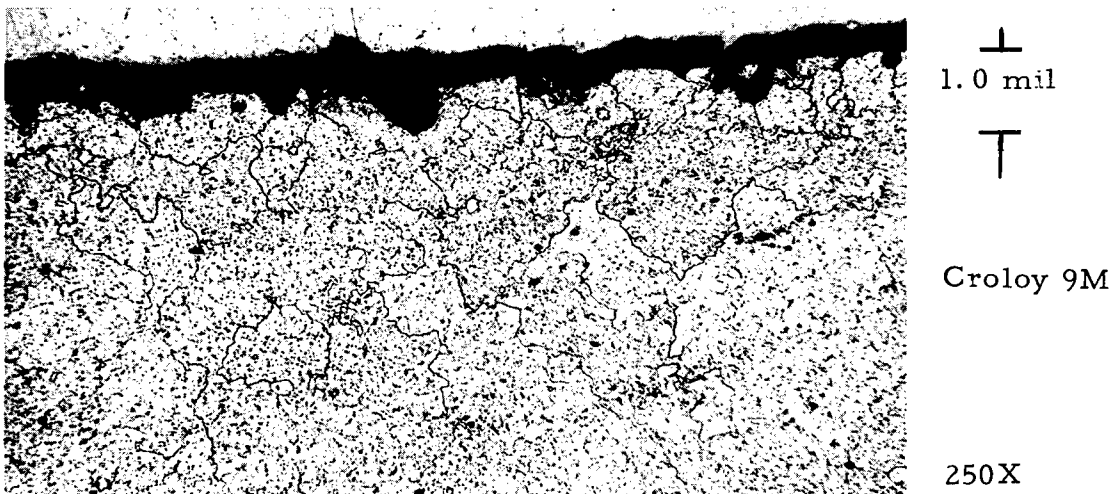
Figure 35. Typical Intergranular Corrosion of Croloy 9M at Inlet to Superheater.

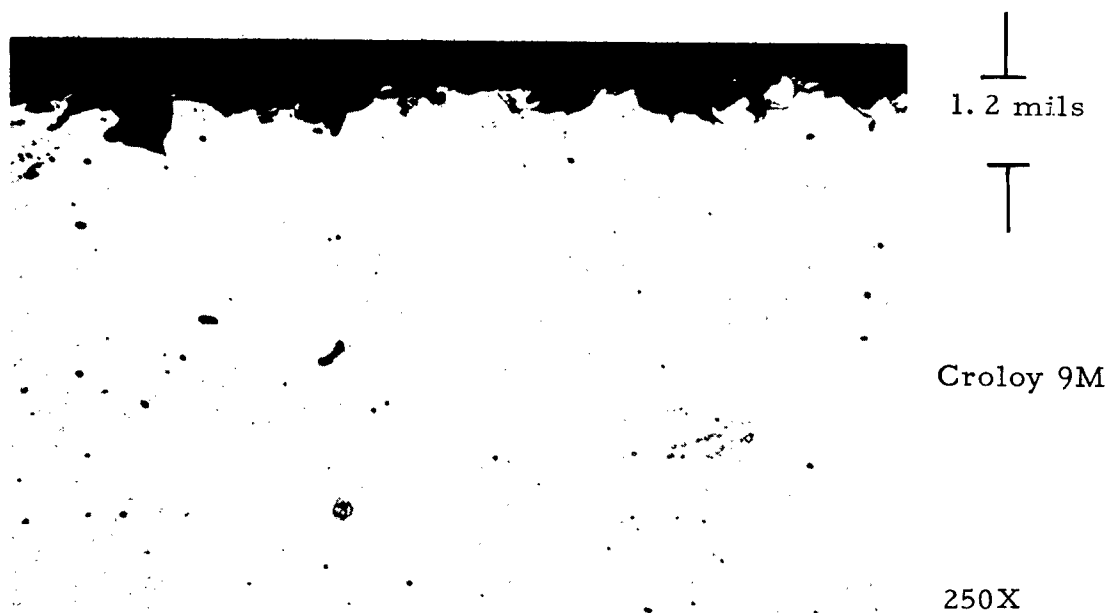
Figure 36. Intergranular Corrosion of Croloy 9M at Superheater Outlet.

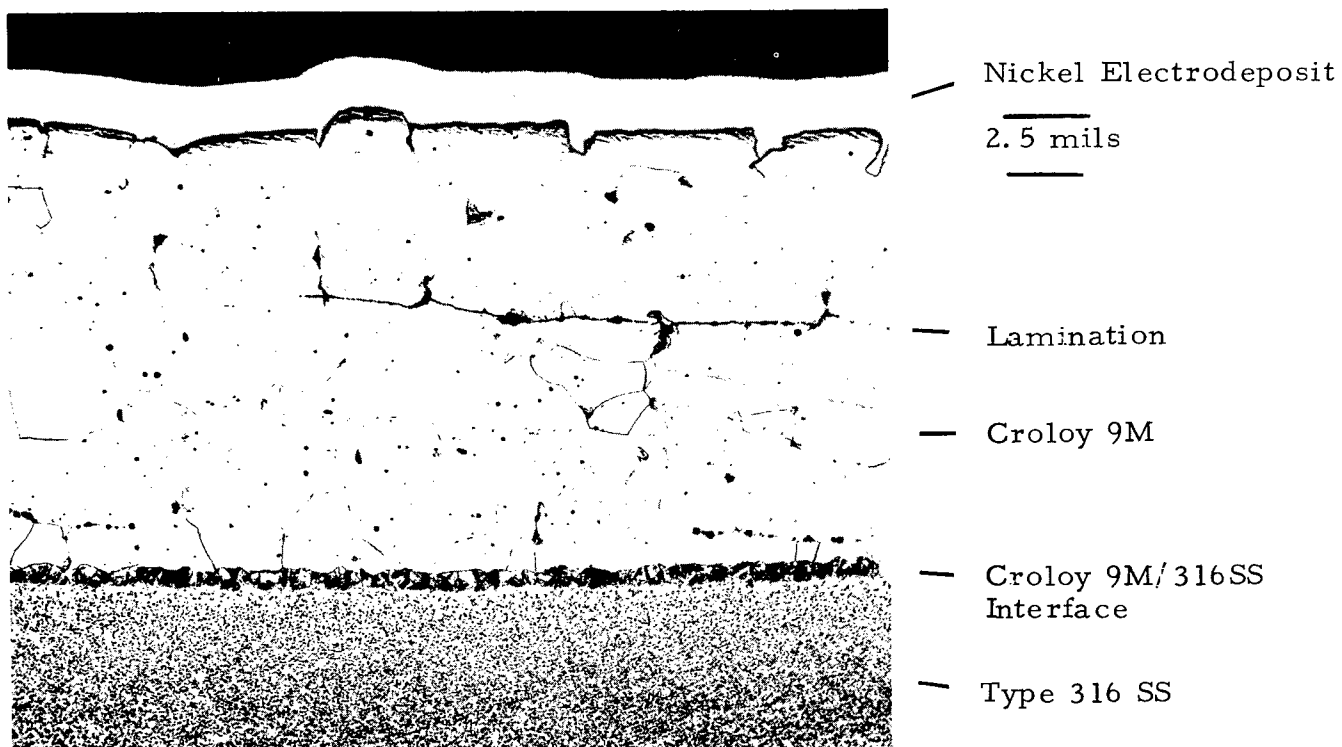
Figure 37. Intergranular Corrosion of Superheater Wall.

The microstructural change of the Croloy 9M in the superheater outlet section of this loop is clearly displayed in the photomicrograph of Figure 37. The normal grain structure of this ferritic steel has been replaced by an extremely low carbon, coarse grain ferrite. Apparently, long time elevated temperature exposure with intimate contact to Type 316 SS promoted the migration of carbon from the Croloy 9M to the austenitic stainless steel, accompanied by grain coarsening of the ferritic steel. The loss of carbon by the Croloy 9M did not change its original hardness ( $R_B 85-96$ ) significantly. The acquisition of carbon by the Type 316 SS cladding material was manifested by a profusion of carbides (Figure 37) and an appreciable change in hardness,  $R_B 96$  to  $R_C 29$ . The electron beam microanalysis of this section of tubing revealed extensive molybdenum and chromium-rich precipitates in the Type 316 SS, which are probably carbides. The electron beam microanalysis also revealed a diffusion zone at the Type 316 SS—Croloy 9M interface of 1.7 to 2.2 mils in thickness (see Figures 54 and 55). This diffusion zone is also displayed in the photomicrograph of Figure 37. This extensive diffusion zone in the superheater outlet section (operated at  $1405 \pm 10^\circ\text{F}$ ) is compared with that observed in the boiler mid-section (operated at  $1142^\circ\text{F}$  and displayed in the photomicrograph of Figure 32). The diffusion zone in this lower-temperature region of the loop was found to be less than 0.3 mil in thickness, as revealed by the electron beam microanalysis (see Figures 56 and 57). The observed gross carbon diffusion and metallurgical structural changes of the Type 316 SS—Croloy 9M tubing in the  $1405 \pm 10^\circ\text{F}$  temperature region is, of course, attributed to the excessive temperature.

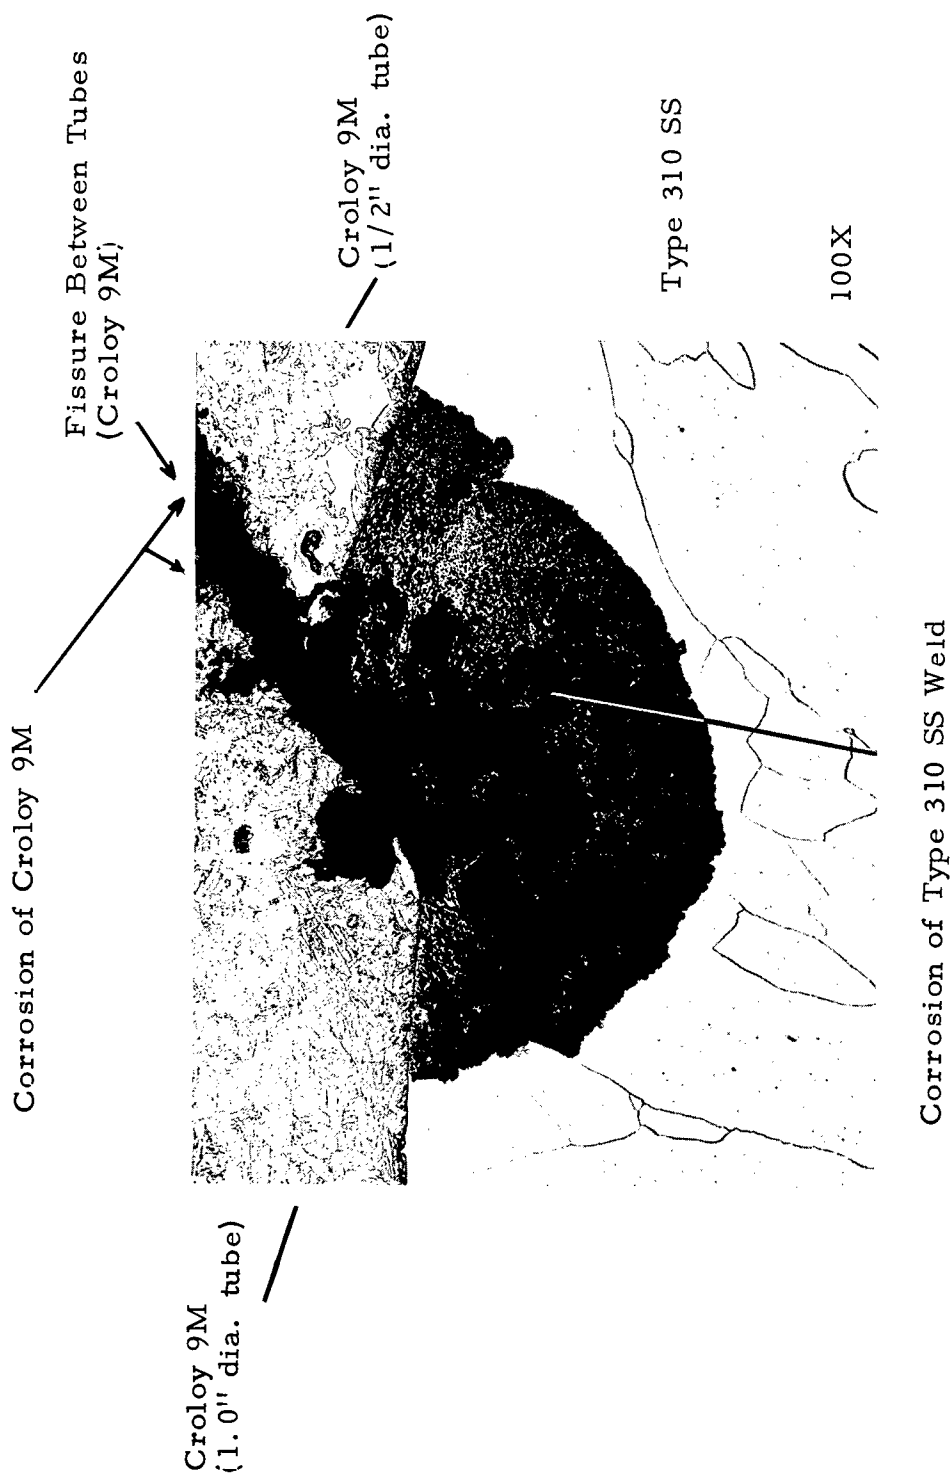
Figure 38. Leached Layer Corrosion of Type 310 SS Weld Metal and Croloy 9M at Weldment of 1/2 Inch Diameter Croloy 9M Tube to 1.0 Inch Diameter Duplex Tube (Croloy 9M/316 SS) in Boiler Section. Operating Temperature—1070°F. Etchant - Carapella.

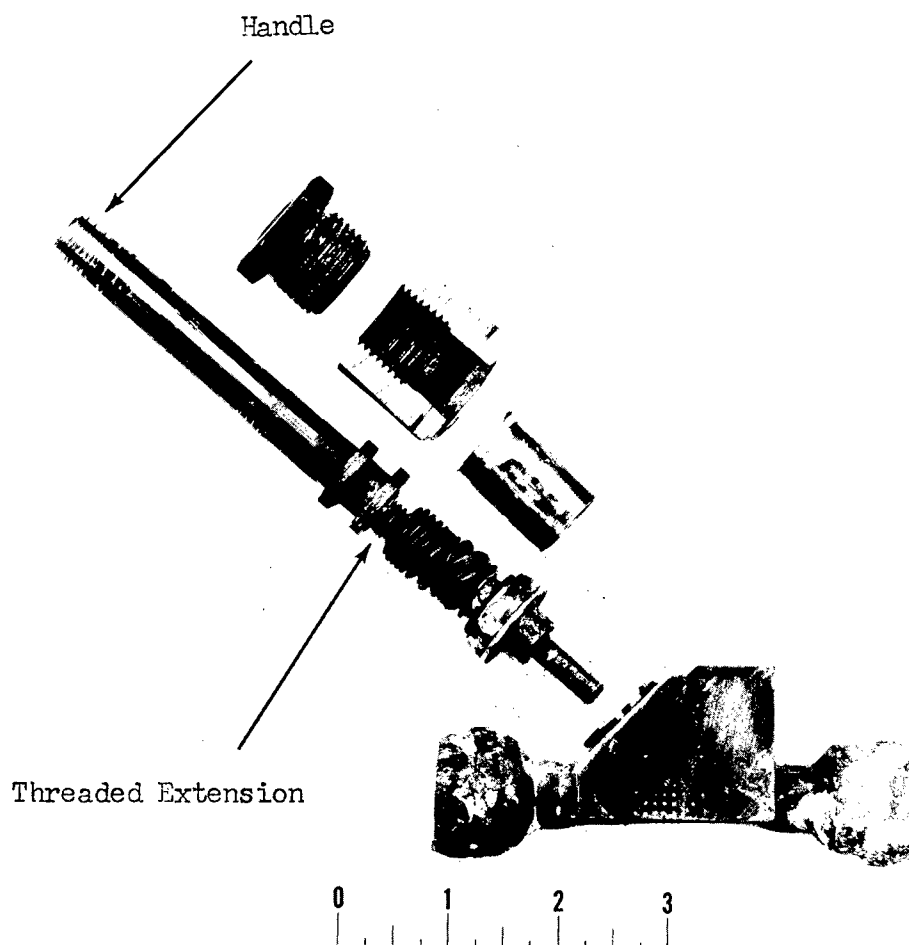
An electron beam microanalysis was performed on the larger of the two metallic chips and on the deposit by Advanced Metals Research Corporation. A careful comparison of the iron, chromium, and molybdenum x-ray line intensities for the base alloy and the metallic chip revealed no significant differences, as seen in Figures 45 and 46. In addition, the manganese and silicon content of these two zones appeared to be identical. It is thus apparent that the metallic chip is Croloy 9M, probably a residual particle remaining in the valve after fabrication of this component.

Figure 42. Disassembled Croloy 9M Throttling Valve.

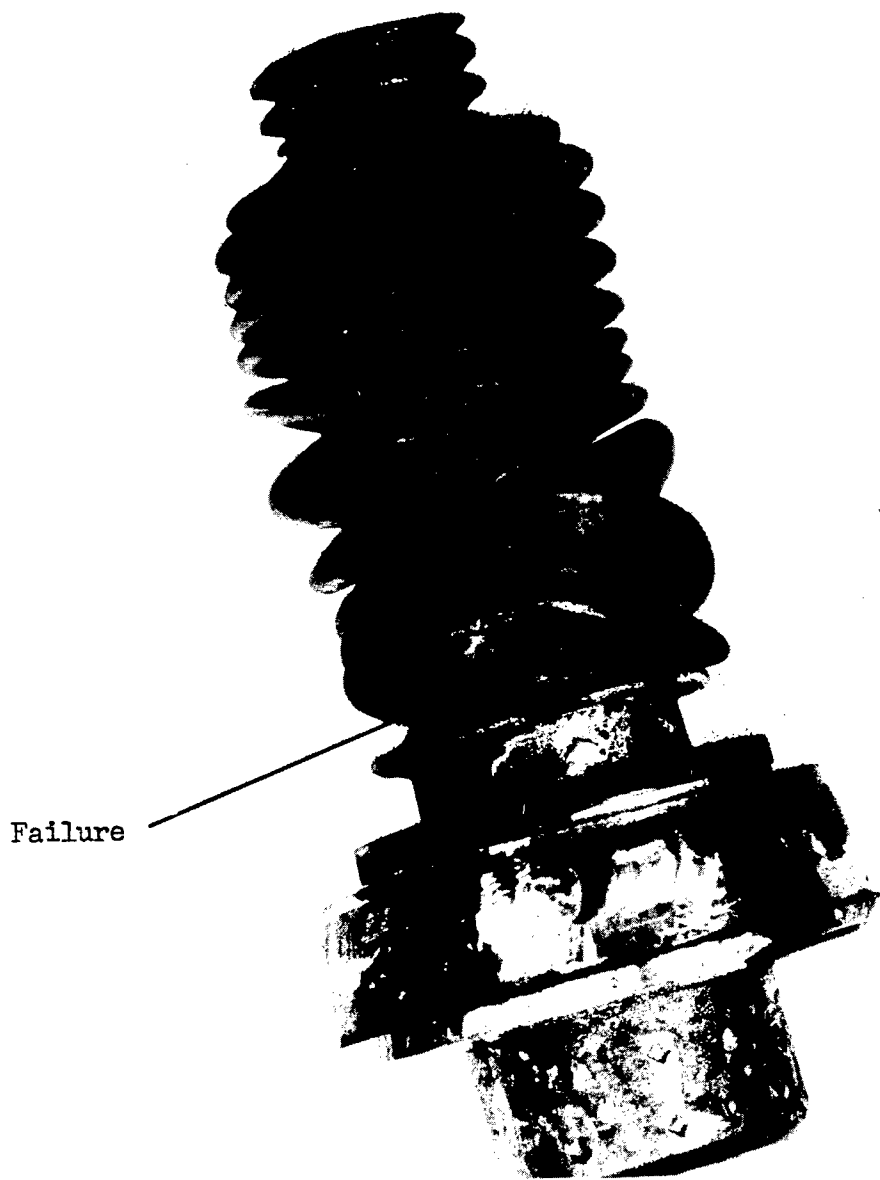
Failure

Figure 43. Type 321 SS Bellows from Croloy 9M Throttling Valve.

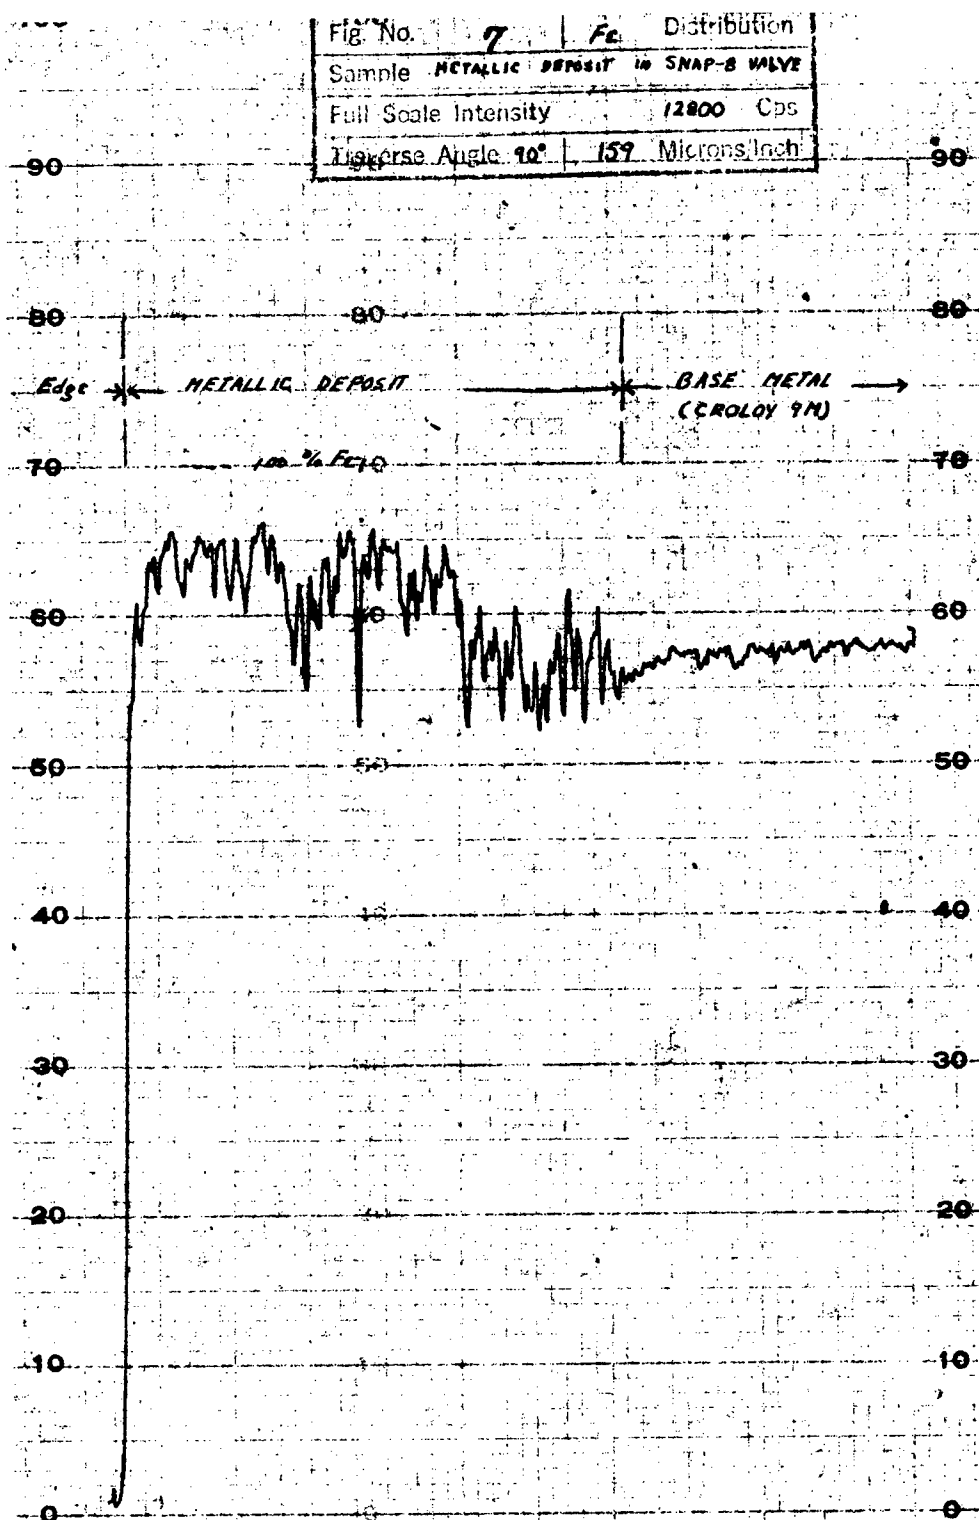
The iron, chromium, and molybdenum distributions in the deposit are shown in Figures 47, 48, and 49, respectively. It is seen here that the deposit is iron-rich and chromium- and molybdenum-poor. The chromium shows a small gradient in the vicinity of the deposit-base metal interface but rapidly falls to less than one percent. The molybdenum content drops abruptly to approximately zero percent at the deposit-base metal interface. The iron concentration rises to roughly 90 to 95 percent. Chromium-rich phases are present in both the deposit

Figure 47. Distribution of Iron in the Deposit Found in the Croloy 9M Throttling Valve.

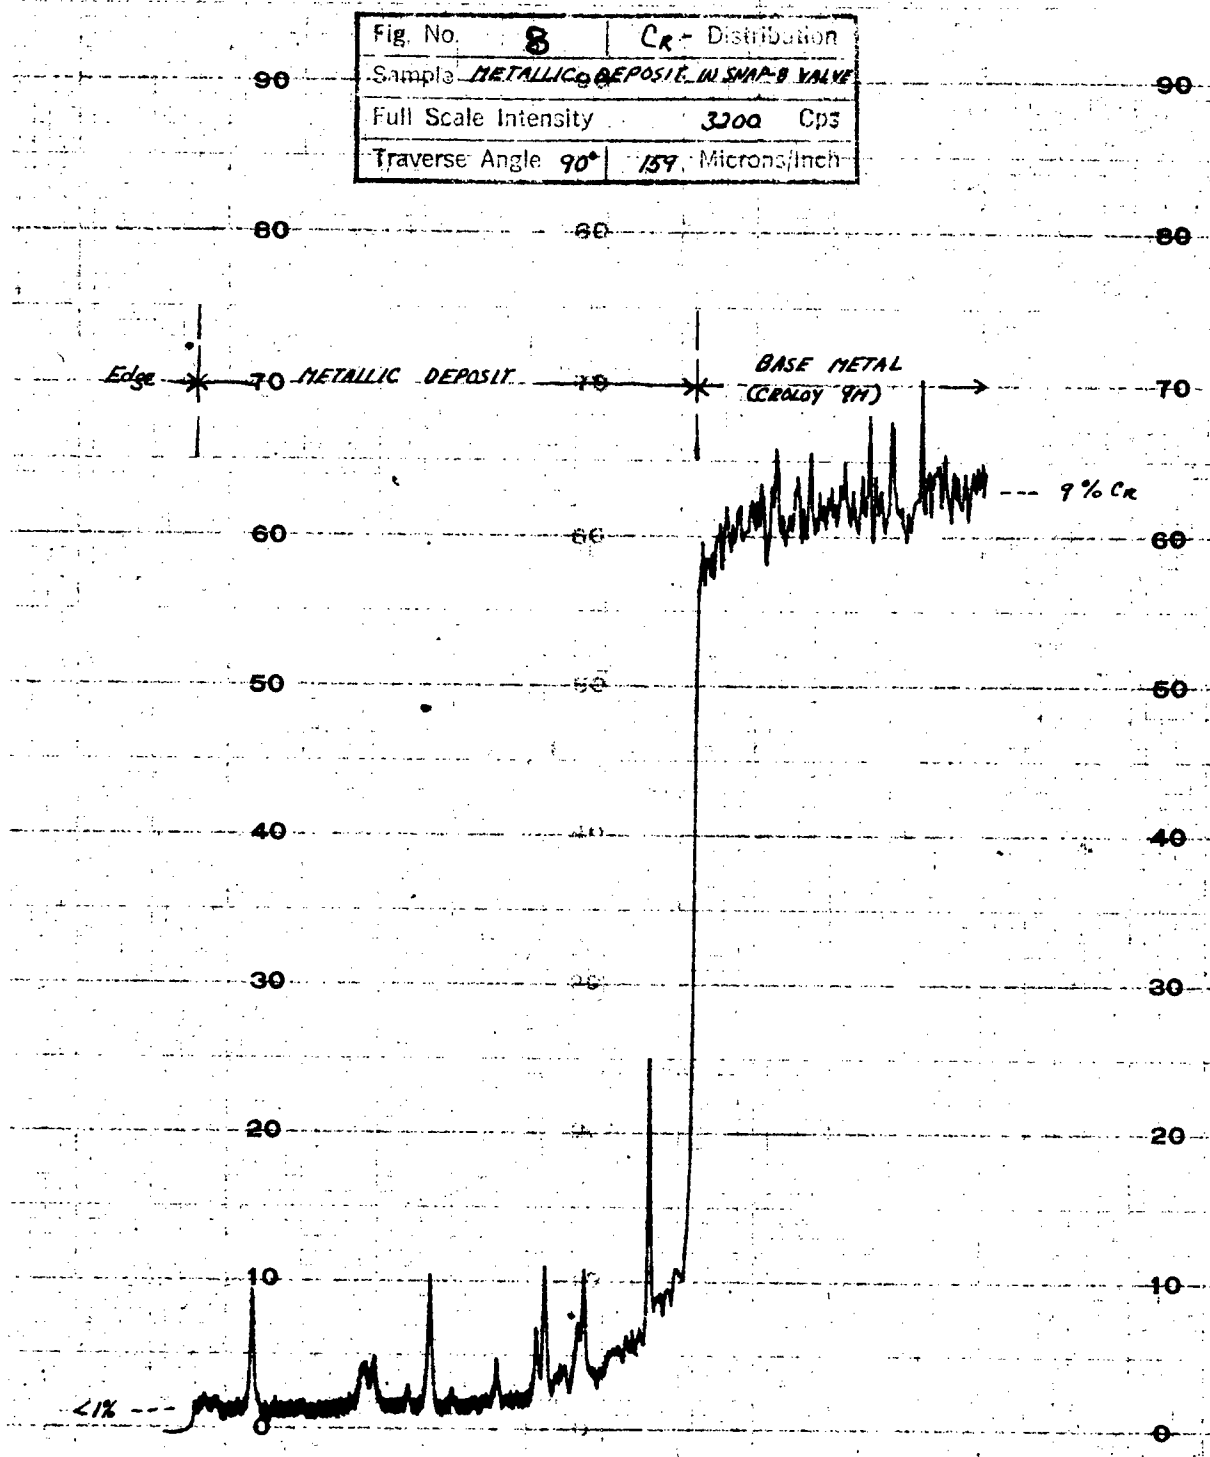
Figure 48. Distribution of Chromium in the Deposit Found in the Croloy 9M Throttling Valve.

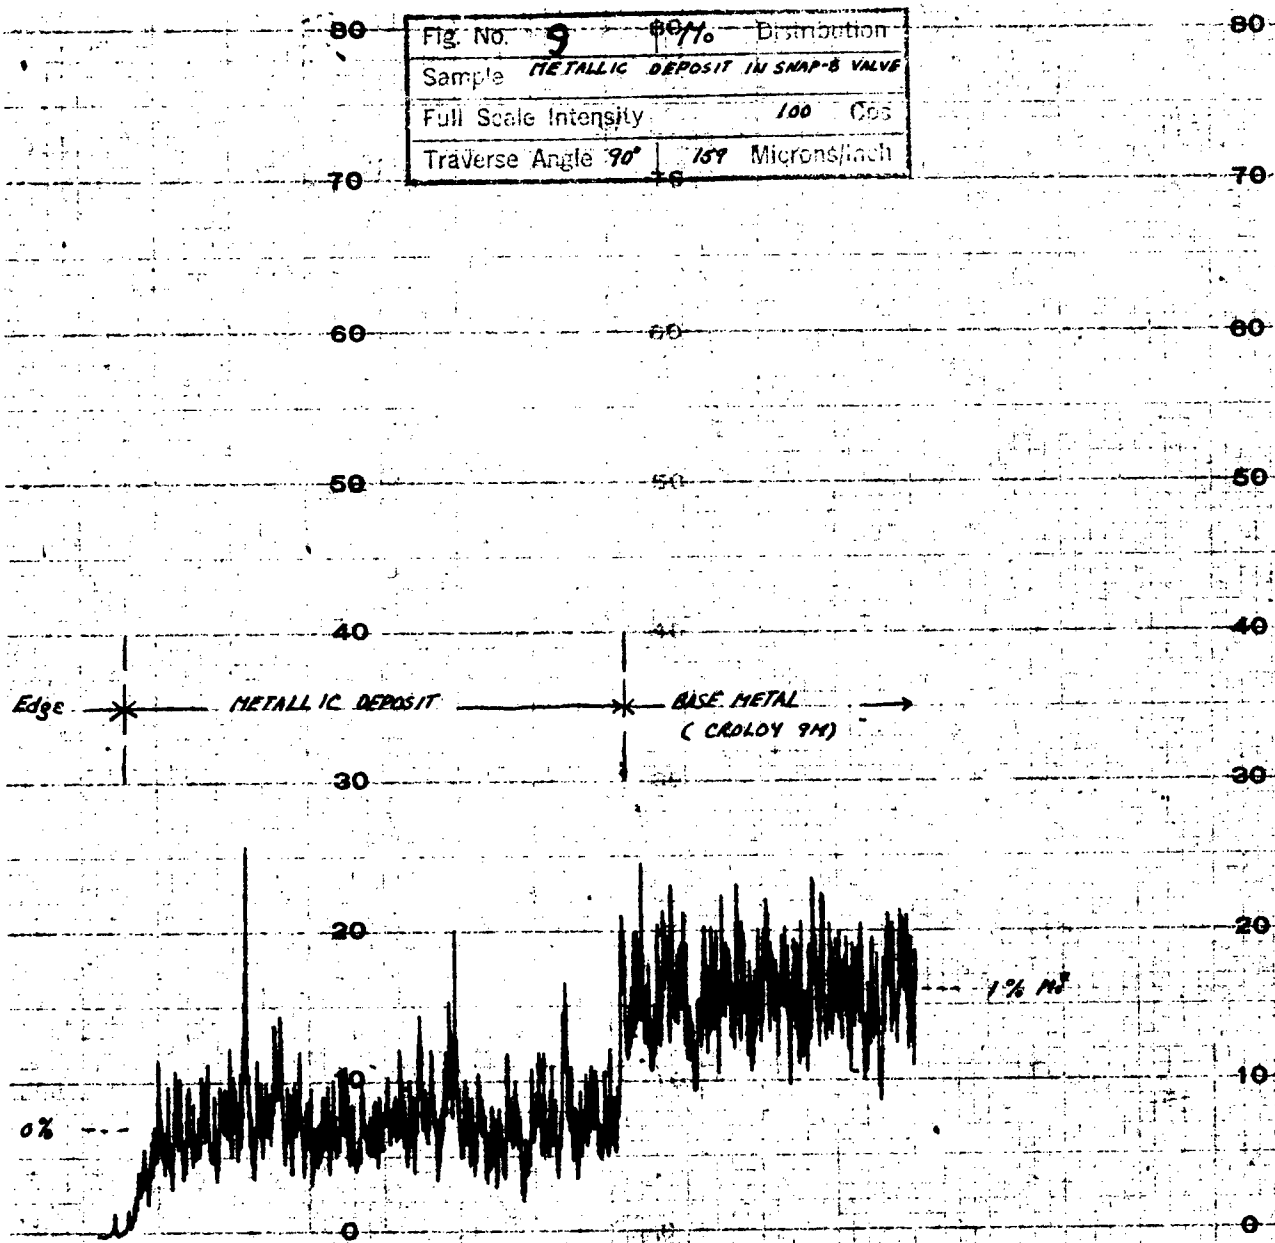
Figure 49. Distribution of Molybdenum in the Deposit Found in the Croloy 9M Throttling Valve.

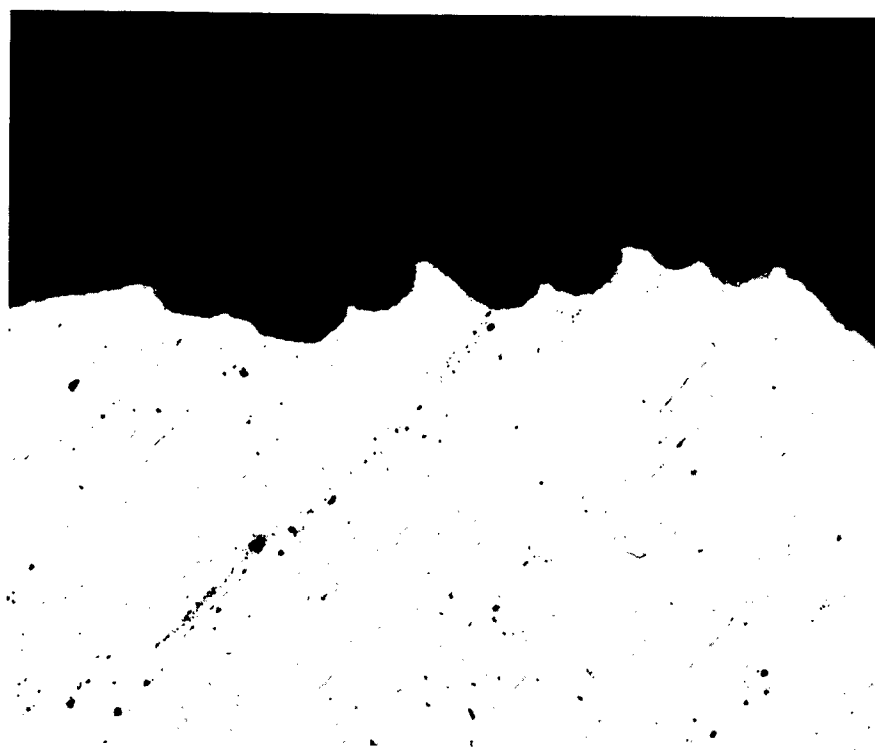
Figure 51. Attack on the Stem of the Croloy 9M Throttling Valve.

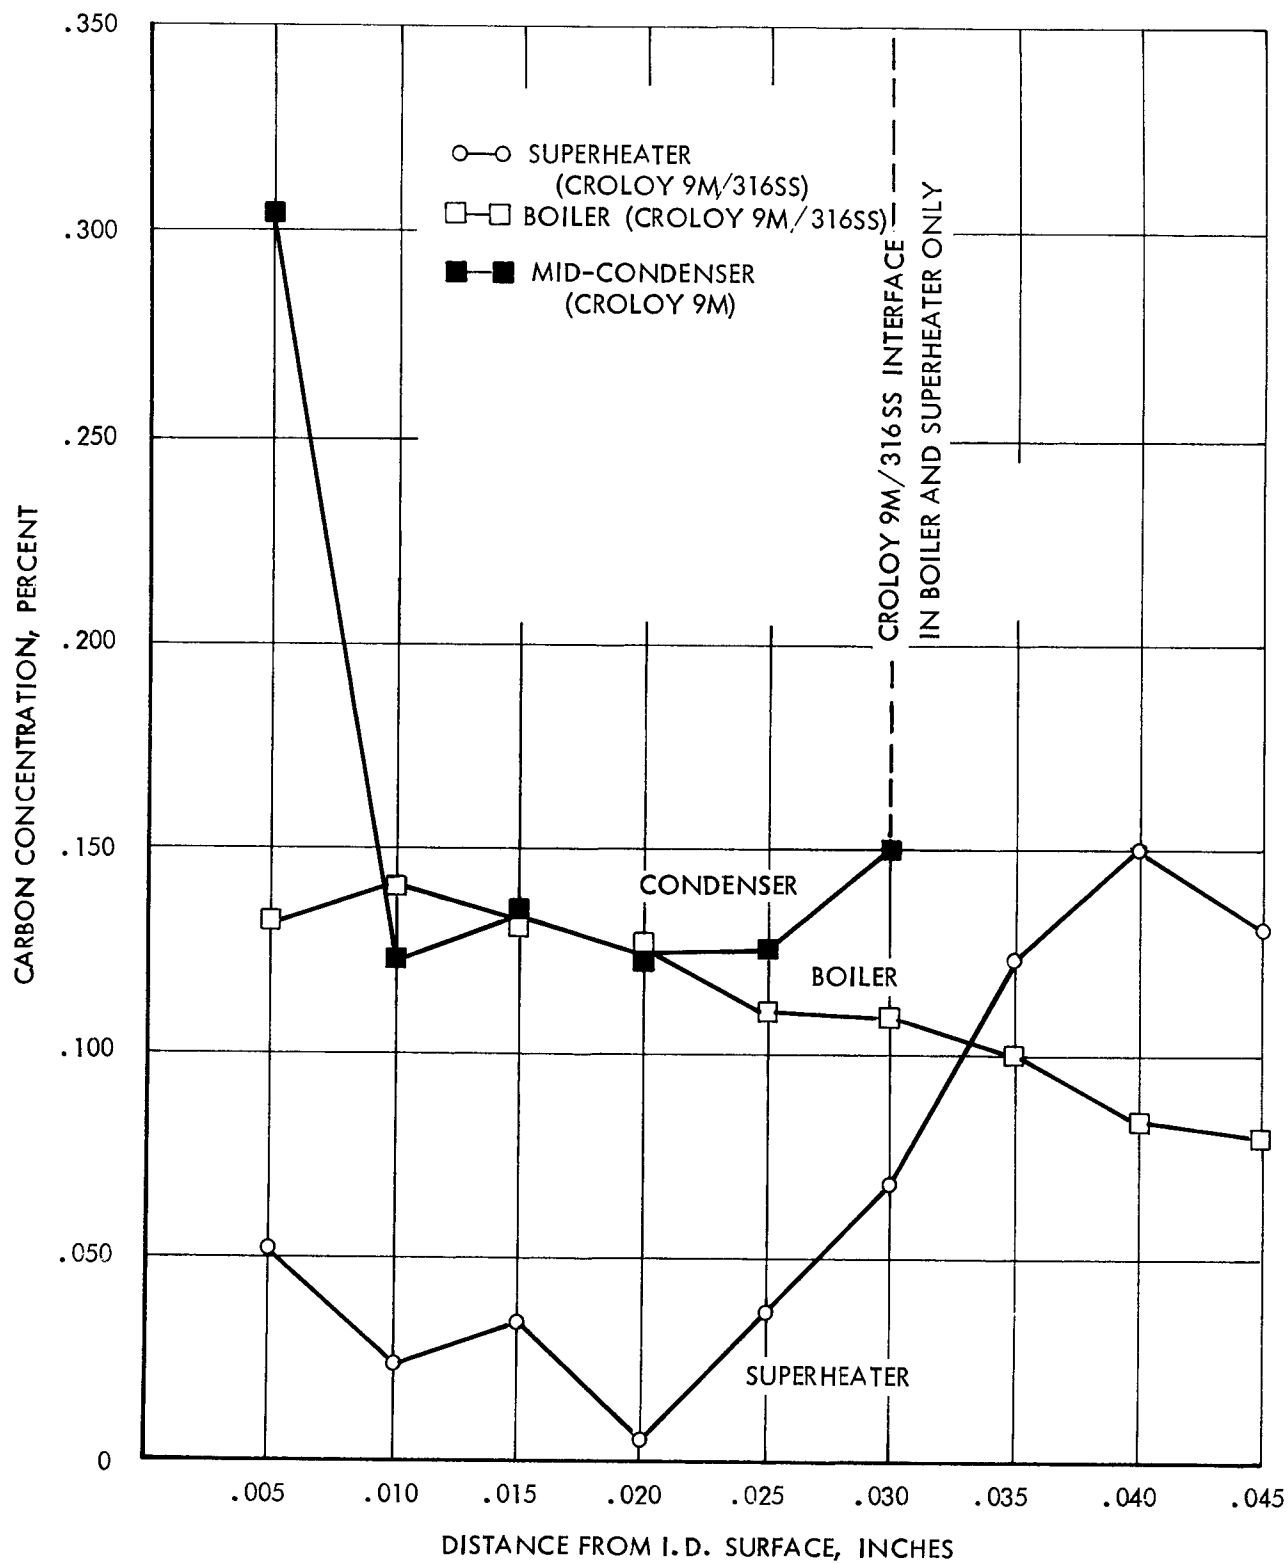
Figure 53. Carbon Content of Loop Wall at Various Distances from the I.D. Surface.

It is apparent from these carbon analyses that the Type 316 SS—Croloy 9M composite tubing is subject to metallurgical changes because of carbon diffusion at temperatures above 1200°F. Furthermore, it is indicated from these results that carbon is lost by the Croloy 9M by diffusion to the Type 316 SS cladding.

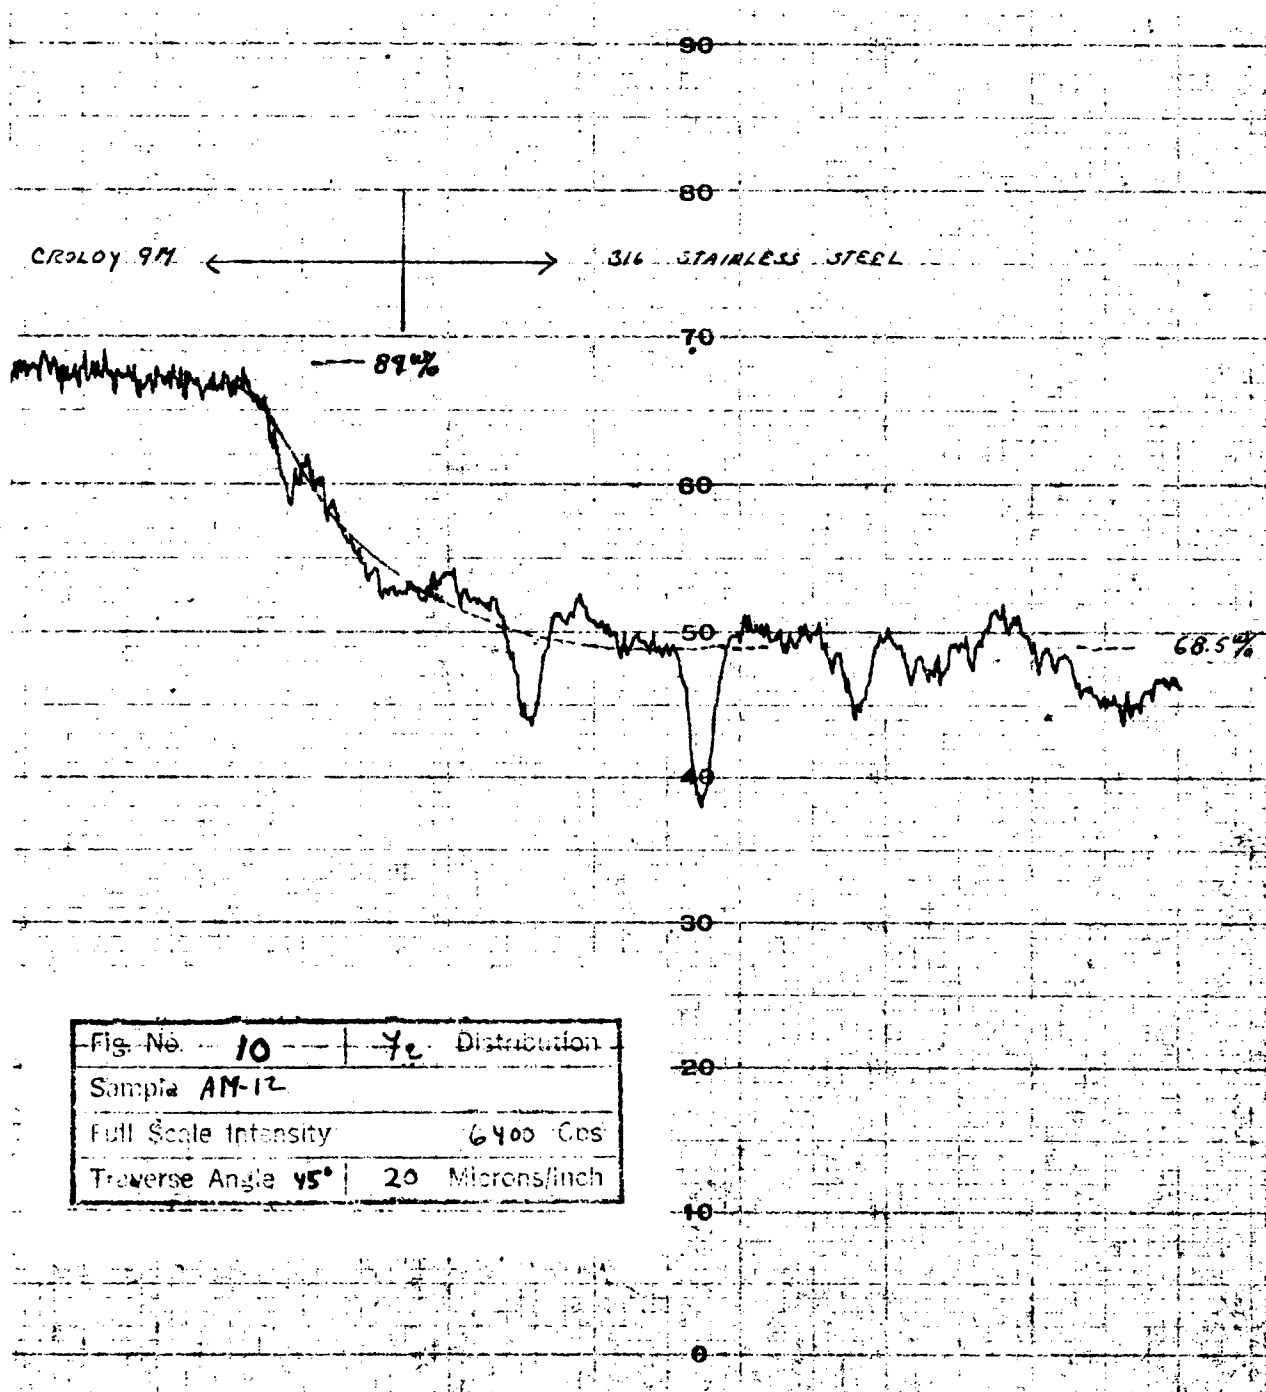
Figure 54. Distribution of Iron at the Type 316 SS-Croloy 9M Interface in the Superheater Outlet.

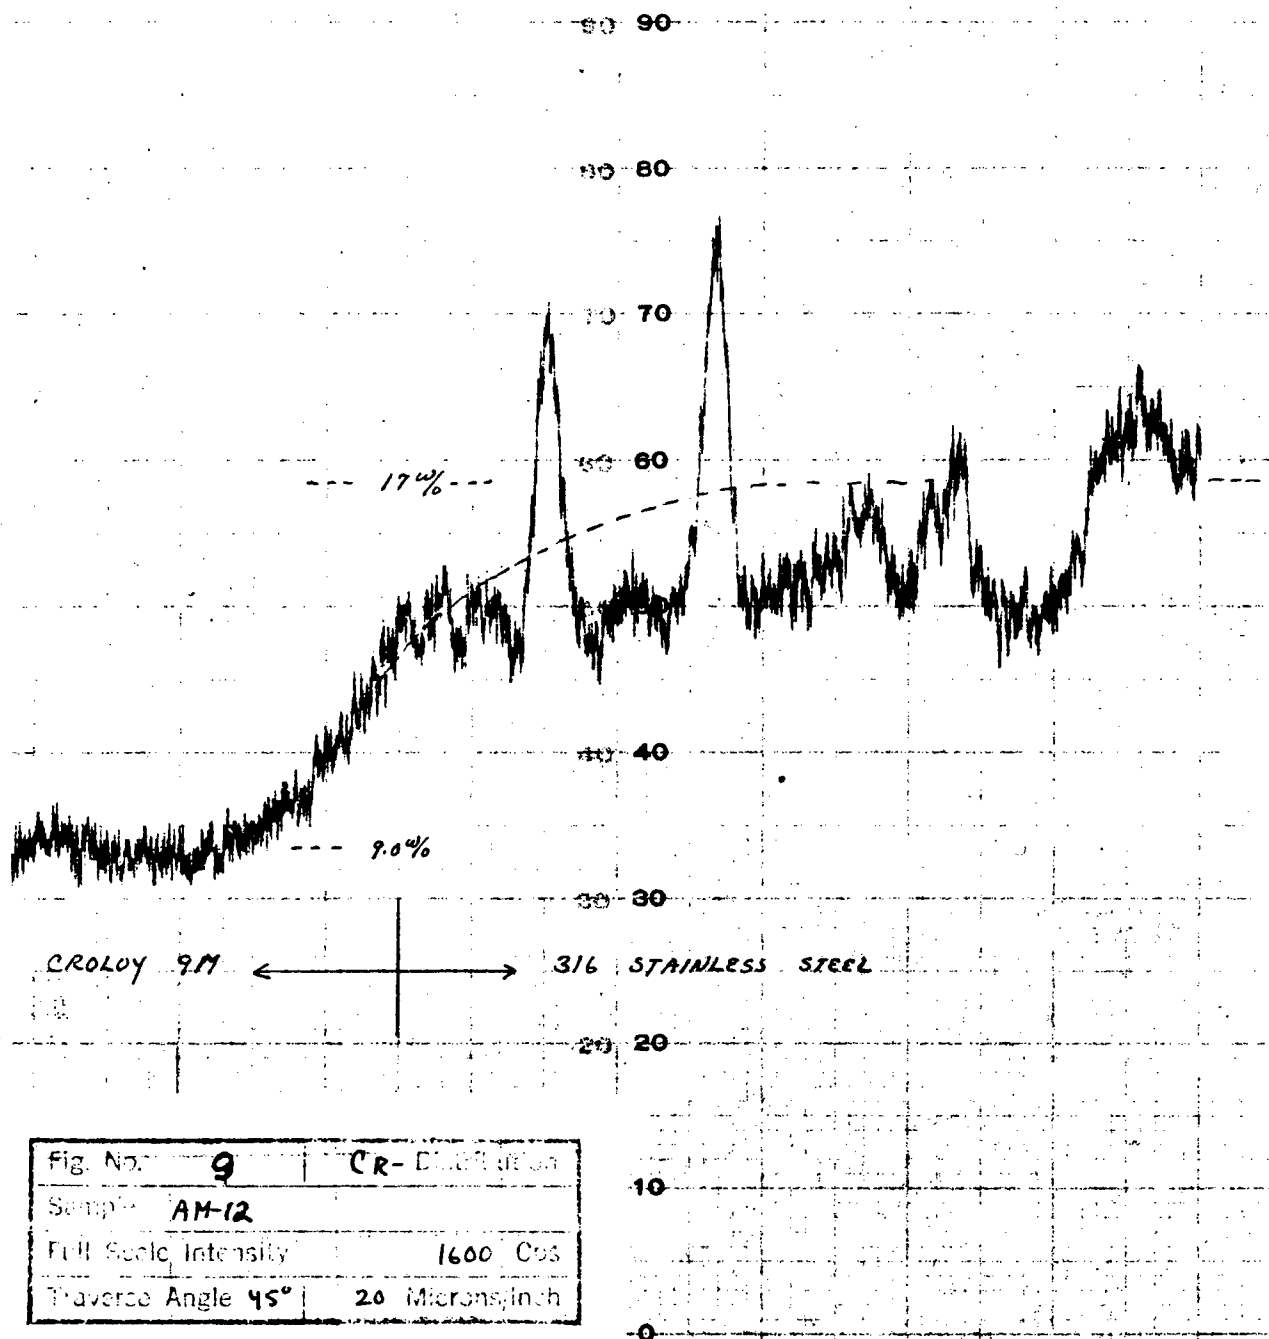
Figure 55. Distribution of Chromium at the Type 316 SS-Croloy 9M Interface in the Superheater Outlet.
